Airborne Communications in Operation Market Garden

David Bennett

Bennett, David "Airborne Communications in Operation Market Garden." Canadian Military History 16, 1 (2007)

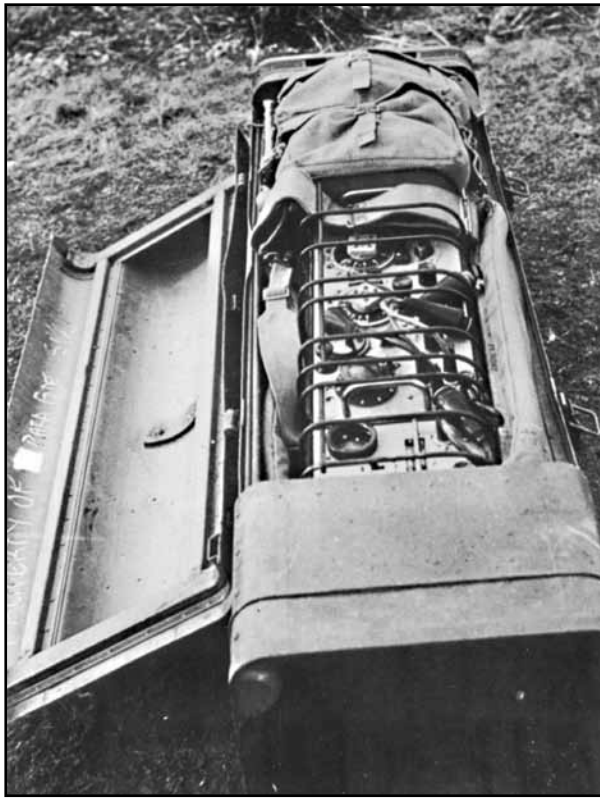
This is the first page of the specification notes for the No. 19 Wireless set made by Captain Ivor Green, of REME (Royal Electrical and Mechanical Engineers). The No. 19 set was used by the artillery net in Market Garden, providing a link between 1st Airborne Division and Lieutenant-Colonel Frost's battalion at the Arnhem bridge. On D+4, the artillery link was established between 1st Airborne Division and the 64th Medium Artillery Regiment. Not only was this effective for artillery support but the link provided a relay to XXX Corps and to Second Army for air support to 1st Airborne.

GENERAL Designed primarily for use with armoured division: two channel communication; one channel on 'A' set between 2.5 & 6.5 Mc/s on the Mk I, and 2.8 Mc/s on Mk II's & III's. Other channel is on frequency of 230-240 Mc/s Mk I, II & III, and are on the 'B' Set.

The 'A' Set channel is for use between squadron HQ and ACV or link AFV etc. 'B' set channel is for use between I.C.'s of the same squadron or troop.

This set is also installed in wireless trucks, L.C.V's etc. and is in use to a smaller extent with the army co-operation command and RAF in Temahawk, Lyngsdales, Mustangs aircraft. It is also used by the latter service as a ground station.

RANGE. Mk I, II & III A SET. RT, 8' rod: -10 miles between AFV's

" " " " B " 800 yds " "

CW range approx 2 1/2 times that of RT.

Range between aircraft & aircraft & ground station are greater but no definite figures are quoted. The following were given by Pye Ltd. as a guide & relate to the A Set only:—

Between aircraft, airborn:— 12-16 miles.

" " & ground st:— 50 miles.

POWER SUPPLIES. (A) 12v supply HT rotary & set heaters are connected in parallel

(B) 24v supply, -ve earthed. Set heater between earth & 12v +ve. Rotary from 12-24 volts

(C) 24v supply, +ve earthed. Set heater between earth & -ve 12 volts. Rotary 12-24 volts.

The Artillery Net. Artillery communications worked well in Market Garden. On the evening of D-Day, about 750 paratroopers under the command of Lieutenant-Colonel John Frost of 2nd Parachute Battalion had occupied the north end of the Arnhem road bridge but they were isolated from the balance of 1st Airborne in Oosterbeek. On the morning of D+1, the artillery link opened between Divisional HQ Royal Artillery and 3rd Airlanding Light Battery HQ at the Arnhem road bridge. Not only did Frost get artillery support but the link enabled Division to open communications with 2nd Battalion for the first time since it left the Drop Zone on D-Day. Using the powerful 19HP sets, Divisional HQ Royal Artillery then contacted the 64th Medium

Regiment Royal Artillery at about 0930 hours on D+4, again resulting in very effective artillery support for 1st Airborne but also opening a relay to XXX Corps for the first time. However, this link was poor at night and had its limitations, as will be seen.

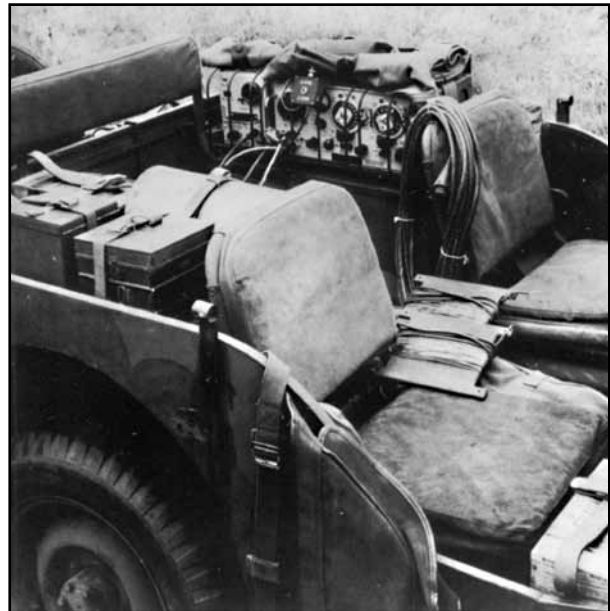
British 1st Airborne Division planned to use the No.22 wireless set to communicate with the British Airborne Corps. Unfortunately, the six-mile range of the set could not reach the 15 miles to Corps Headquarters. **Left:** A No.22 Set in a specially designed container for airborne drops. **Above:** A No.22 Set mounted in an airborne jeep.

The problem with 1st Airborne was that Divisional Signals were using No.22 radio sets which had a maximum range of six miles when Corps HQ was 15 miles distant.³³ Reliable communication would only be possible when 1st Airborne HQ moved into Arnhem and thus closer to Airborne Corps HQ, after the second airborne “lift” on D+1. The No.22 sets were mobile on jeeps; they required a hefty charger for the accumulators. But the divisional HQ never did get to Frost’s positions at the Arnhem road bridge. Thus Major-General Urquhart had to rely on the Phantom net. His messages were not acknowledged and he had no way of knowing whether they were received. In fact, the Jedburgh station in Ede received the news that Urquhart’s Phantom connection with the War Office had been cut; this occurred on D+2 or perhaps earlier.³⁴ His operators were given insufficient information to contact XXX Corps, even when they were in range. He eventually established contact with XXX Corps through the artillery link, using the larger No.19HP sets with a voice range of 25 miles. This link worked well and to good practical effect. When 1st Polish Parachute Brigade landed

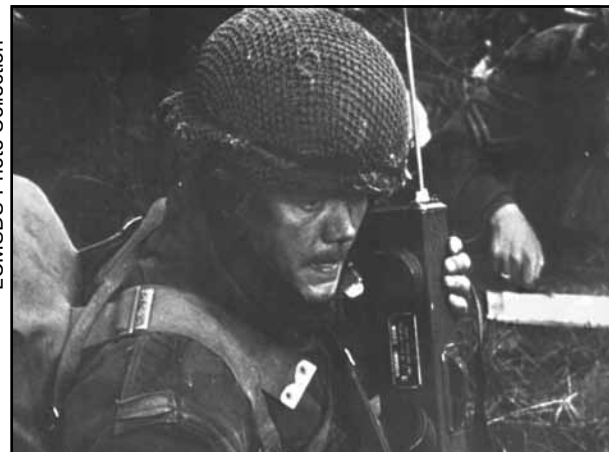
Below: The SCR-536 was a short-range walkie-talkie that did not work effectively during Market Garden. **Right:** One of the ad hoc signals links used by 1st Airborne to communicate with the outside world included sending messages to the War Office through the BBC net, which used morse keys and the No.76 Set.

Within the battalions, the companies and platoons used very short range SCR-536 sets. The reconnaissance squadron used its own radio net; there never was an effective link within the Squadron, with Division or 1st Parachute Brigade on D-Day.

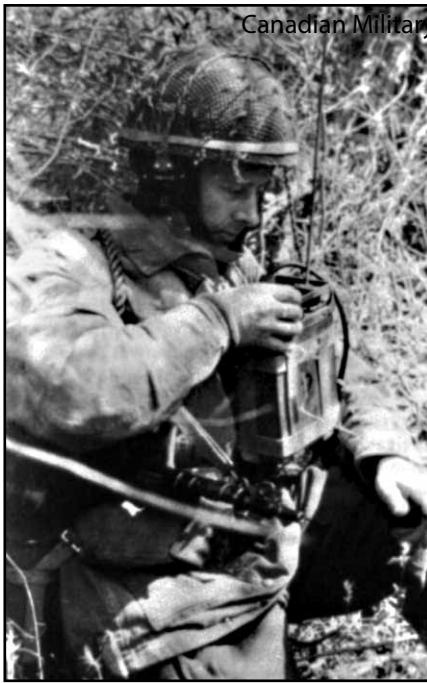
Left: A British paratrooper at Arnhem attempts to make use of a No.68P set. This set proved largely inadequate as it had a range of only three miles and suffered from shortage of batteries.

failure was not a principal reason for defeat at Arnhem.⁵⁰ As for the contention that signals worked better than could be expected: the division was using unsuitable equipment, with rough handling owing to constant loading and unloading; the hazards of dropping and landing; the difficulties of tuning sets under battle conditions and battle damage itself. The iron in the sandy soil at Arnhem, buildings and trees impeded both transmission and reception. Shortage of the replaceable batteries for the 68P sets was also a problem.⁵¹

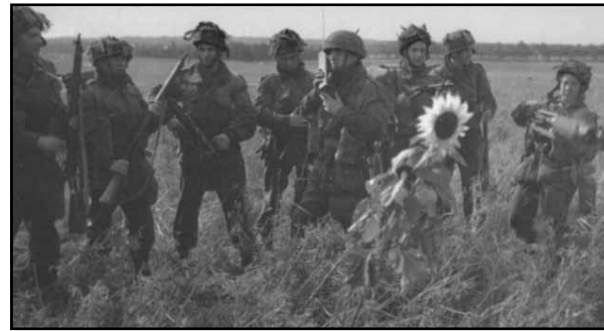
Right: Paratroopers of "C" Section, 1st Airborne Divisional Signals, gather on DZ "X" shortly after their drop at Oosterbeek on 17 September 1944. The soldier in the centre is using the SCR-536 walkie-talkie.
